## Weber River Safety and Access Proposal

December 10, 2019

Submitted by:

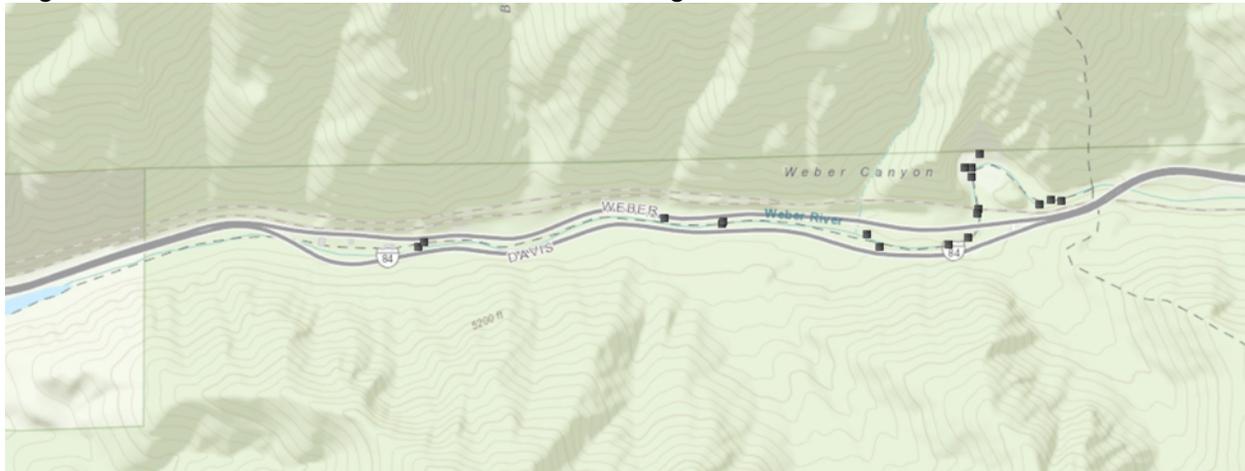
Figure 1. Locations of industrial debris within the high-water channel of the Weber River.

We documented the existence of 2 large pieces of metal debris, 16 small pieces, as well as three small grade control drops made of concrete. All debris was characterized as typical of a

heavily developed river reach, and none have caused problems with paddlers in the past over many years of documented use. The 18 pieces of metal debris were embedded pieces of rebar, cable, pipe, chain, or wire. Most pieces were located on or along one river bank and posed little or no risk to paddlers. Results of the assessment are documented in Appendix 2.

There is nothing that poses an atypical risk to a paddler while in their boats except for some old wires hanging down into the river that will be easy to remove. The two large pipes entering the river do pose some entrapment risk, however those risks are similar to natural trees, are obvious, are easily avoided, and can be easily mitigated by signage and scouting or portaging. More debris poses some minor risk to swimmers, but other than the debris mentioned above, those risks are low and typically associated with trauma caused by stepping on or swimming into a piece of debris rather than death by entrapment. These kinds of risks are ubiquitous in many rivers that experience vast recreational use including on Forest Service lands and operating under FERC licenses. The specific pieces of debris are largely outside of areas where paddlers are likely to swim or step, are small, and are thus very unlikely to pose any kind of safety issue.

We propose to remove the old communication wires from the river channel this winter as a volunteer effort. Easy access to the areas via the gravel road on river right and the small gauge of these wires will make this effort relatively easy. American Whitewater proposes to organize this effort. Once this effort is complete there are no hazards remaining that necessitate delaying flow restoration.

To mitigate the two large non-spanning pipes we propose to include their location on a map with images at the put in and encourage caution, scouting, and if merited, portage. They are obvious and easy to scout and/or portage from the gravel road paralleling the river at that point. We note that they are in low gradient reaches and easy to simply and safely paddle past, so limiting mitigation to informational precautions and proceeding with flow restoration is appropriate.

Remaining debris does not require mitigation prior to flow restoration. With this said, American Whitewater is interested in collaboratively pursuing the removal of all industrial debris from the river over time to enhance the recreation experience, and would welcome partnership efforts to this end.

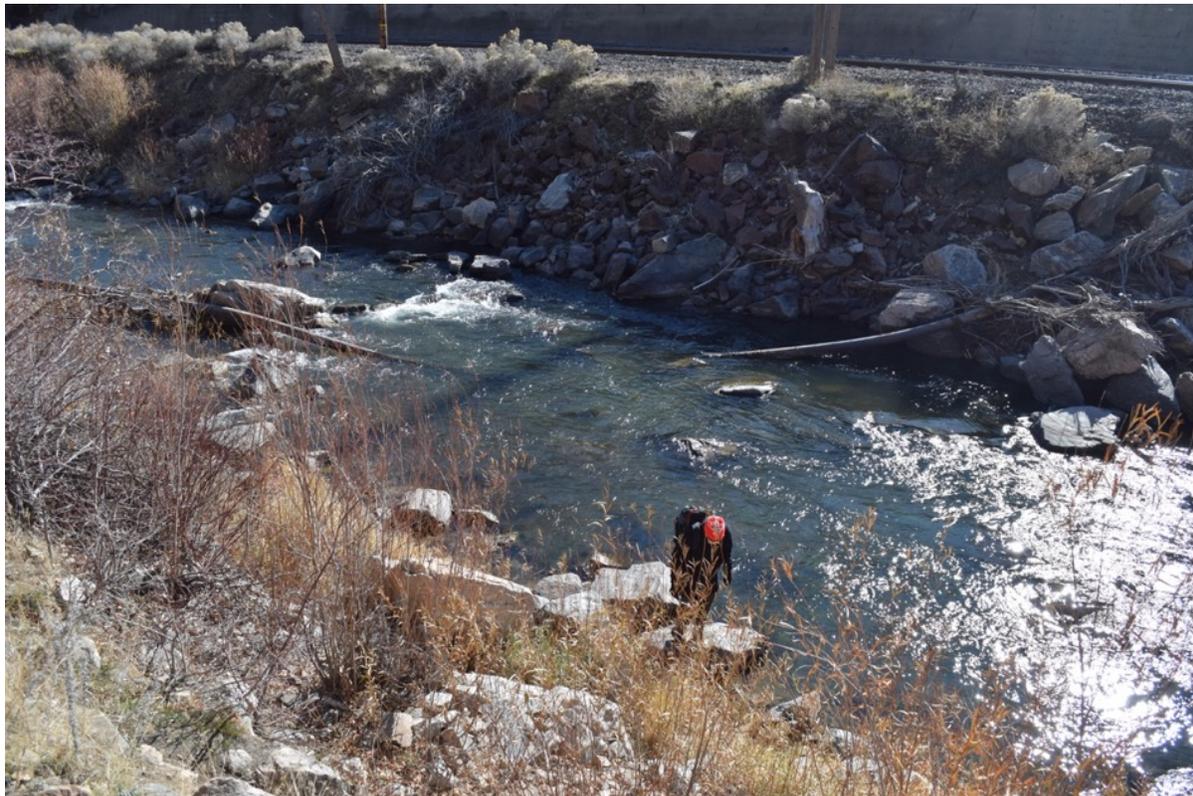
Description	Boat Hazard	Swim Hazard	Proposed Action
1. Large pipe crossing and entering the river.	Low-Moderate. There is a wide gap to safely pass, and velocity is low. Pin potential exists near both banks. Similar to a tree	Low-Moderate. Swimming in to the right side could result in entrapment. Middle and left are fine. Similar to a tree.	Include precautionary location and image on put in sign. Scouting and portaging are easy, as is avoiding the obvious hazard. Eventual removal would be nice.

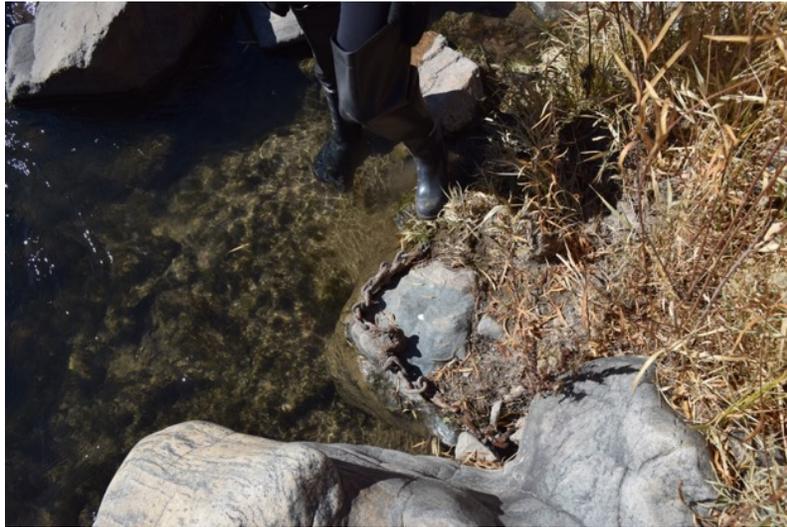
Description	Boat Hazard	Swim Hazard	Action
2. Chain on river right bank	<b>None.</b> It is on the bank and has no space under it.	<b>None.</b> It is on the bank and has no space under it.	<b>None.</b>

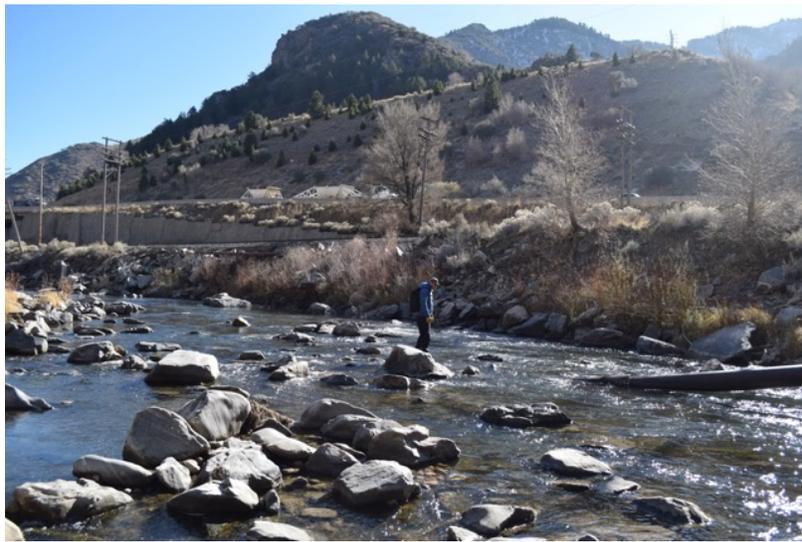
3. Large pipe entering the river on right left.	<b>Low-moderate.</b> Similar to a tree, easily seen and avoided.	<b>Low-moderate.</b> Similar to a tree, easily seen and avoided.	<b>Include precautionary location and image on put in sign.</b> Scouting and portaging are easy, as is avoiding the obvious hazard. Eventual removal would be nice.
---	--	--	---

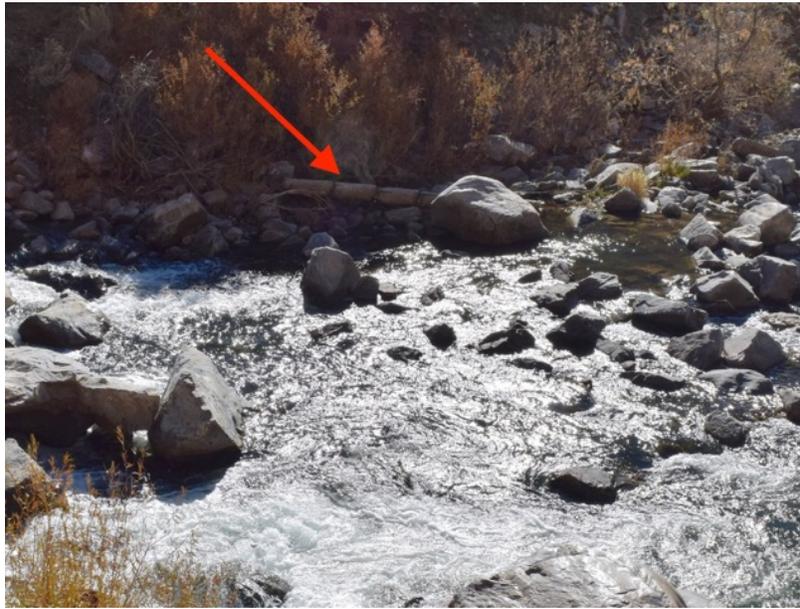
Description	Boat Hazard	Swim Hazard	Action
4. Concrete cylinder with rebar on river right bank.	<b>None.</b> It is on the bank and has no space under it.	<b>None.</b> It is on the bank and has no space under it.	<b>None.</b>

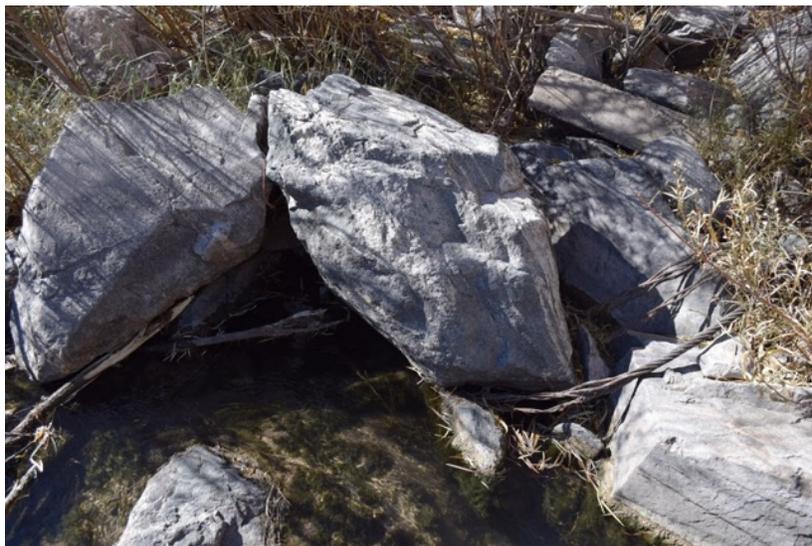
5. Cable fragment mid-river	<b>None.</b>	<b>Low.</b> Almost no space under it, no sharp upstream point.	<b>None.</b>
-----------------------------	--------------	--	--------------

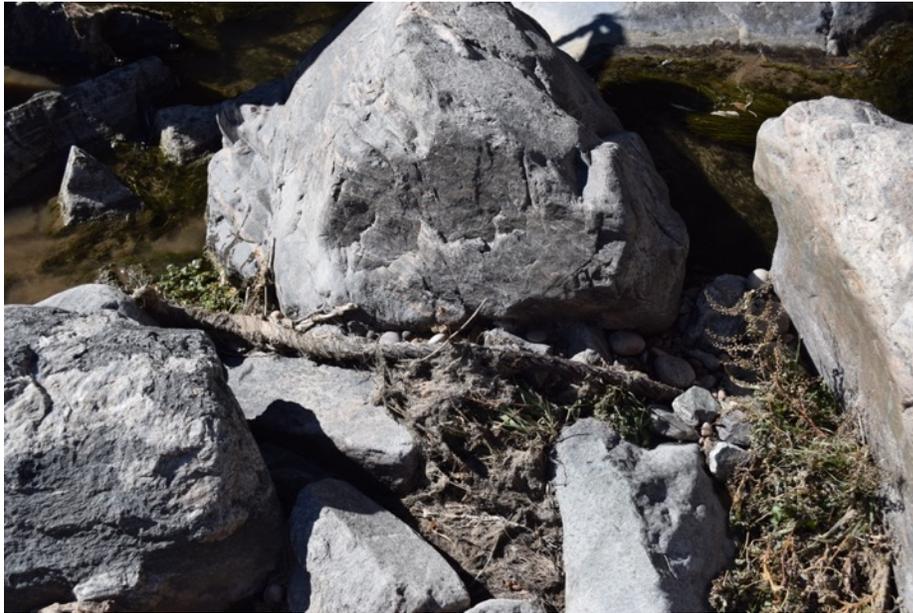
Description	Boat Hazard	Swim Hazard	Action
6. Cable fragment river right.	<b>None.</b>	<b>None.</b>	<b>None.</b>

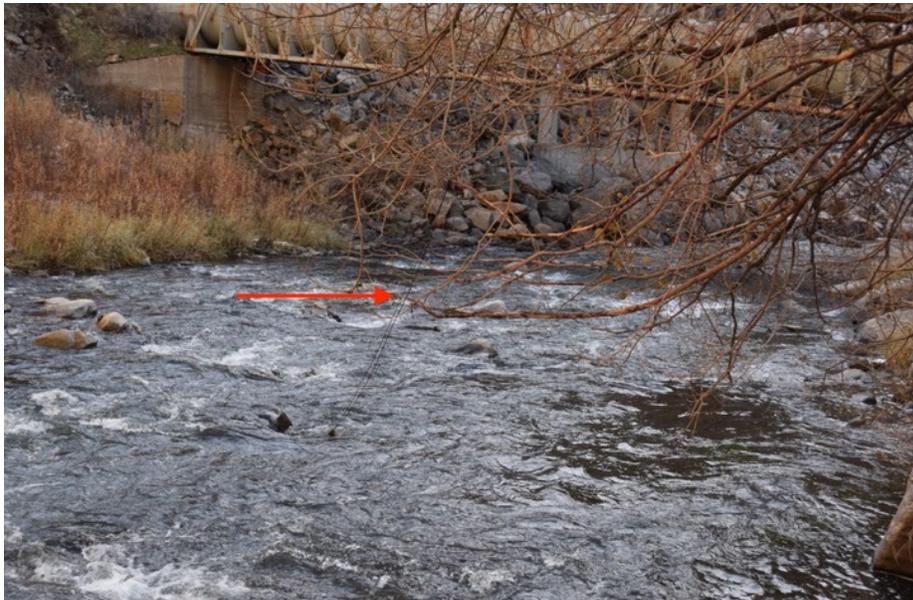
7. Comms wires hanging down into river.	<b>None.</b> Not attached at river.	<b>None.</b> Not attached at river.	<b>Trim if possible</b> to be out of water.
---	-------------------------------------	-------------------------------------	---

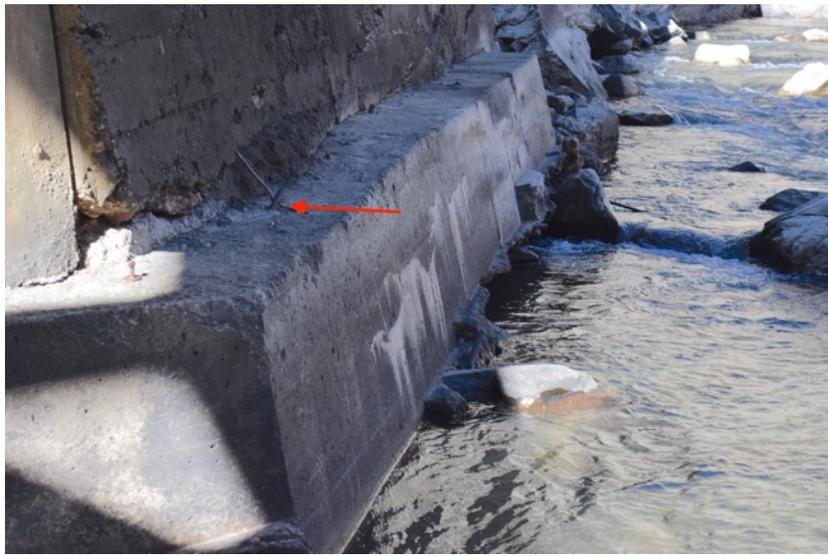
Description	Boat Hazard	Swim Hazard	Action
8. Rebar protruding several inches from bridge abutment	<b>None.</b> Paddlers avoid bridges.	<b>None.</b> Paddlers avoid bridges.	<b>None.</b>

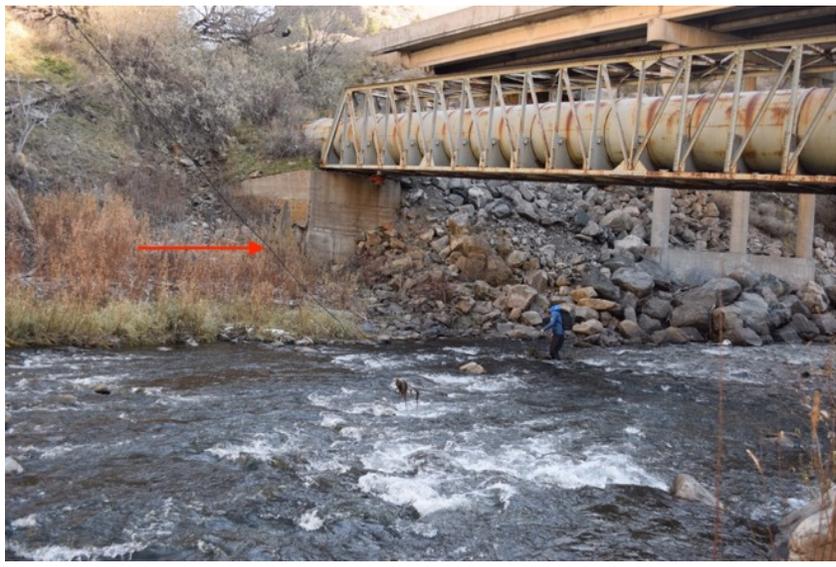
9. Comms wires hanging into river	<b>Moderate.</b> These wires are difficult to see and could entangle paddlers.	<b>Moderate.</b> These wires are difficult to see and could entangle swimmers.	<b>Remove them.</b> Simple effort with easy access.
-----------------------------------	--	--	---

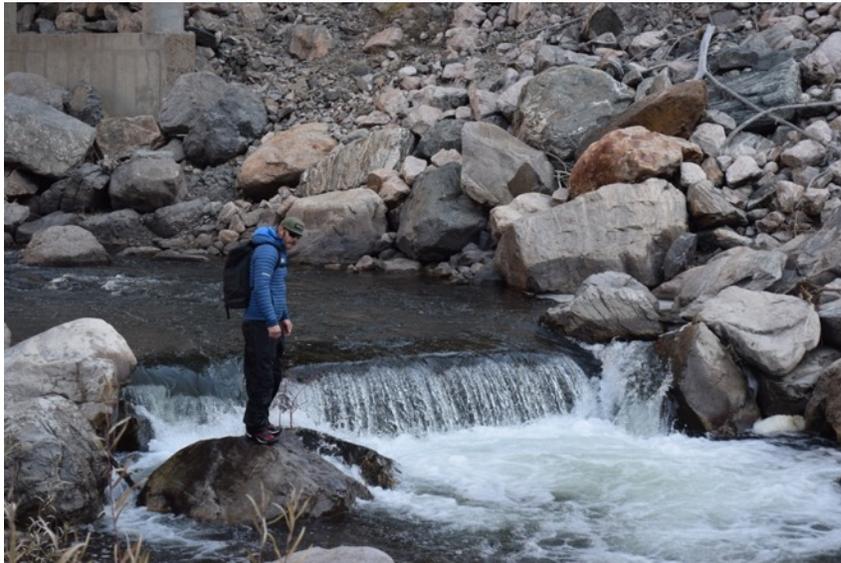
Description	Boat Hazard	Swim Hazard	Action
10. Three concrete grade control drops.	<b>Low.</b> These are actually fun for paddlers. Similar to natural drops.	<b>Low.</b> Similar to natural drops.	<b>None.</b>

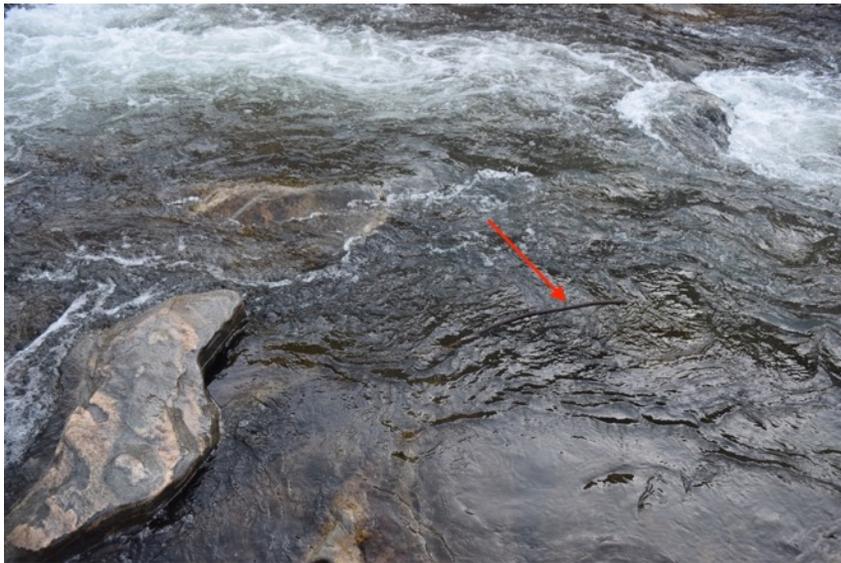
11. Rebar protruding out of water.	<b>None.</b> Pointing downstream and will be underwater.	<b>Low.</b> Pointing downstream so very low entrapment potential.	<b>None needed.</b> Remove if possible.
------------------------------------	--	---	---

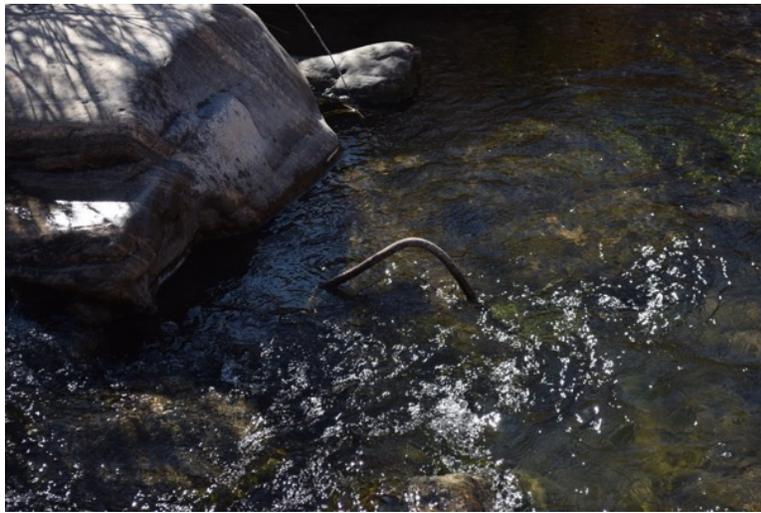
Description	Boat Hazard	Swim Hazard	Action
12. Rebar at head of island. Looped.	<b>None.</b> Will be well under water and not where people paddle.	<b>Low.</b> Not pointy, and out of main flow, so entrapment / injury potential is low.	<b>None needed.</b> Remove if possible.

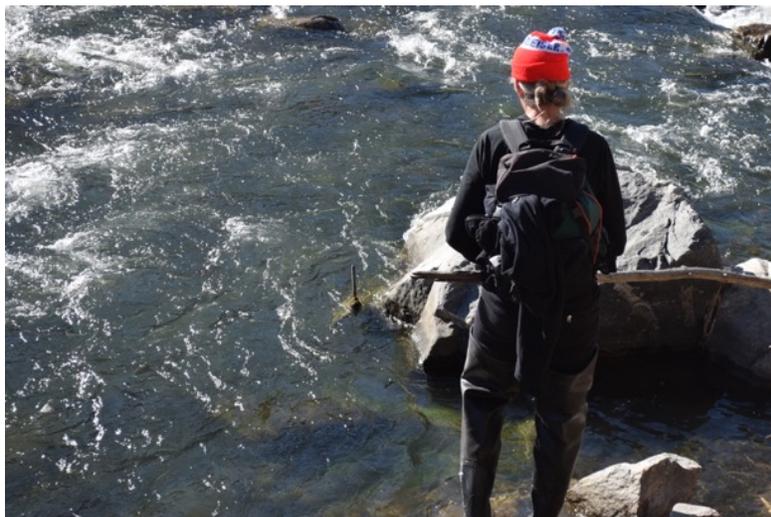
13. Rebar pointing up next to rock	<b>None.</b> Will be under water.	<b>Low.</b> It is flexible so entrapment risk is low, but could injure a swimmer.	<b>None needed.</b> Remove if possible.
------------------------------------	-----------------------------------	---	---

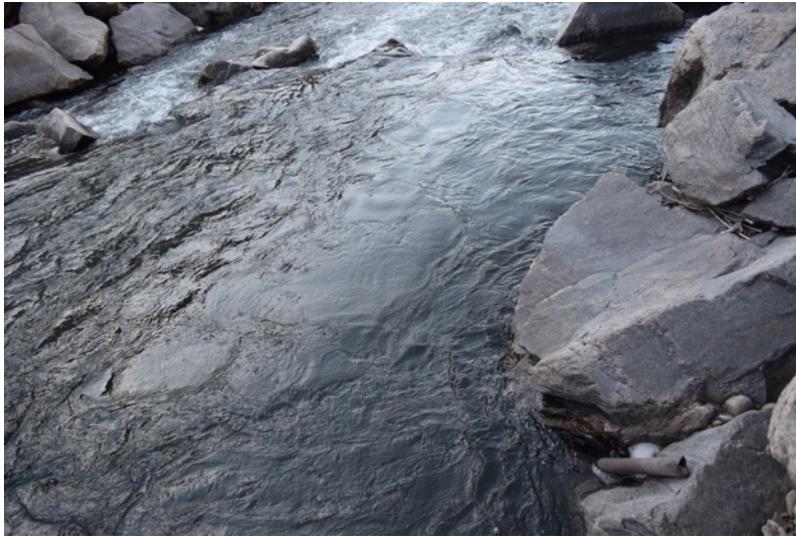
Description	Boat Hazard	Swim Hazard	Action
14. Small smooth pipe on right bank.	<b>None.</b> Entirely touching shore rocks, no entrapment or injury risk.	<b>None.</b> Entirely touching shore rocks, no entrapment or injury risk.	<b>None.</b>

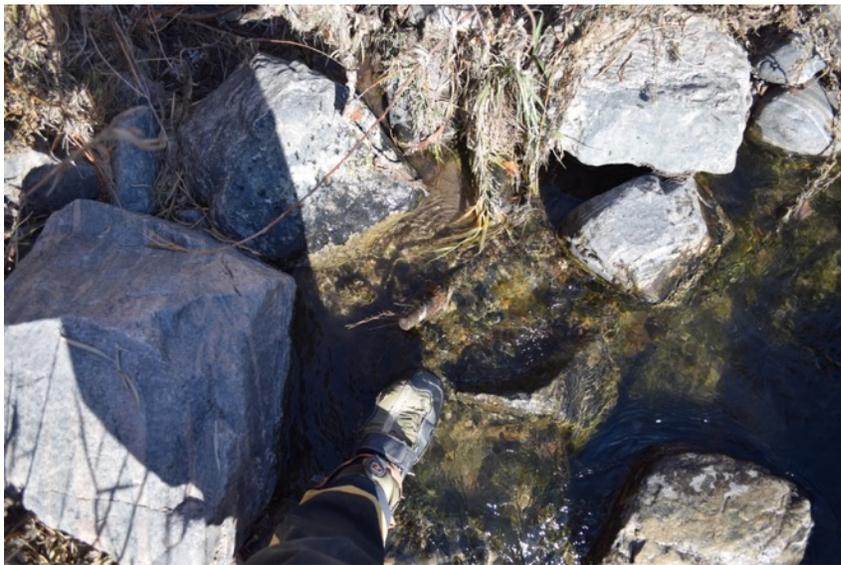
15. Small rebar on river right	<b>None.</b> Will be underwater, along bank, pointing downstream.	<b>Low.</b> On bank and pointing downstream so no entrapment risk.	<b>None.</b>
--------------------------------	---	--	--------------

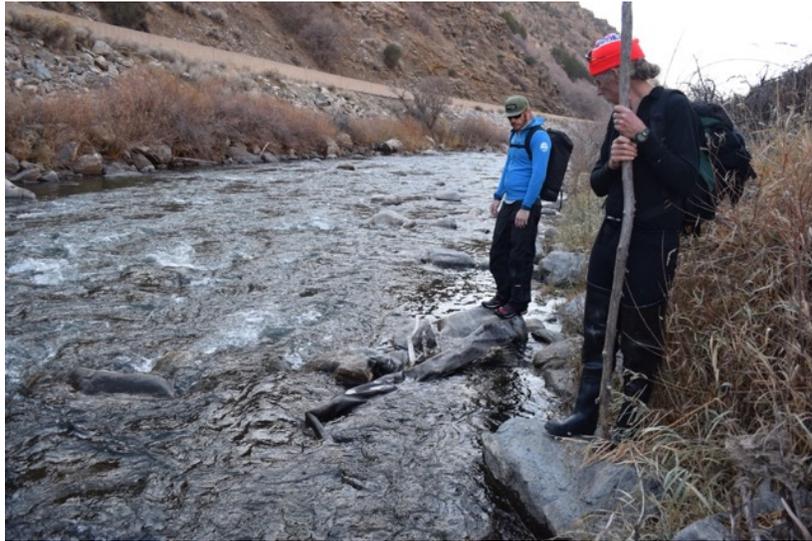
Description	Boat Hazard	Swim Hazard	Action
16. Crushed small metal pipe on river right.	<b>None.</b> Along bottom and smooth.	<b>None.</b> Along bottom and smooth.	<b>None.</b>

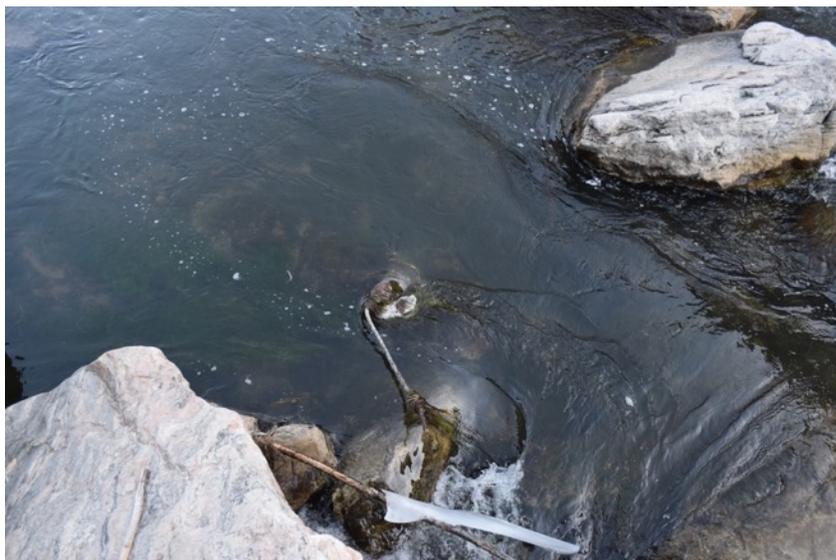
17. Flexible rebar near right bank.	<b>None.</b> It is flexible and pointing downstream so no entrapment hazard.	<b>Low.</b> It is flexible and pointing downstream so no entrapment hazard. Could injure a swimmer.	<b>None needed.</b> Remove if possible.
-------------------------------------	--	---	---

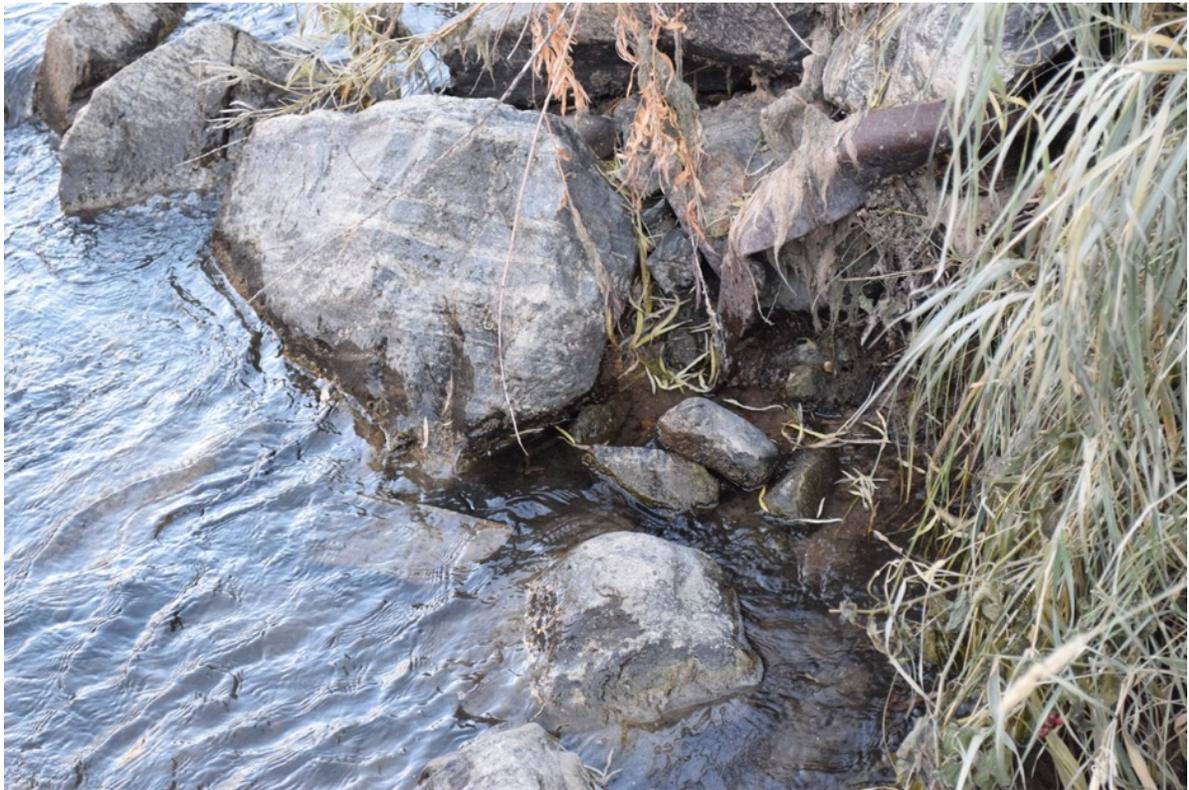
Description	Boat Hazard	Swim Hazard	Action
18. I-bar on right bank	<b>None.</b> Not in paddling channel, Against a rock.	<b>Low.</b> On bank, no entrapment hazard, low injury potential.	<b>None.</b>
[No Photo]			
19. Crushed pipe on river left. Not in play.	<b>None.</b> Smooth, on the bank, and no gaps for entrapment.	<b>None.</b> Smooth, on the bank, and no gaps for entrapment.	<b>None.</b>
